Bank of Montreal Foundation Wall Restoration

Project: Bank of Montreal Barton and James Street

Location: Hamilton, ON

Completion: February 2007

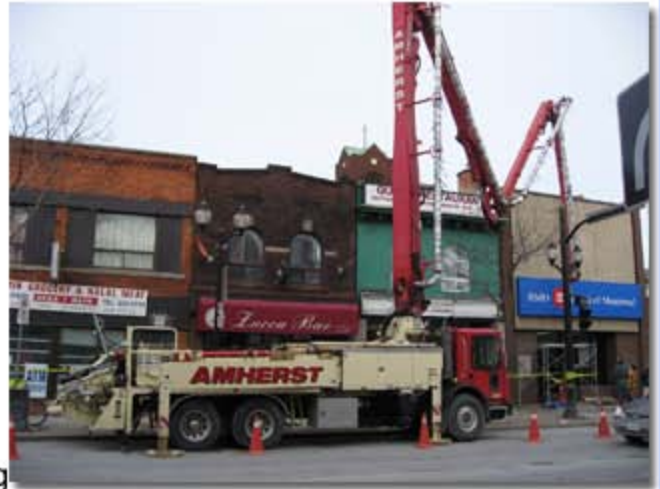
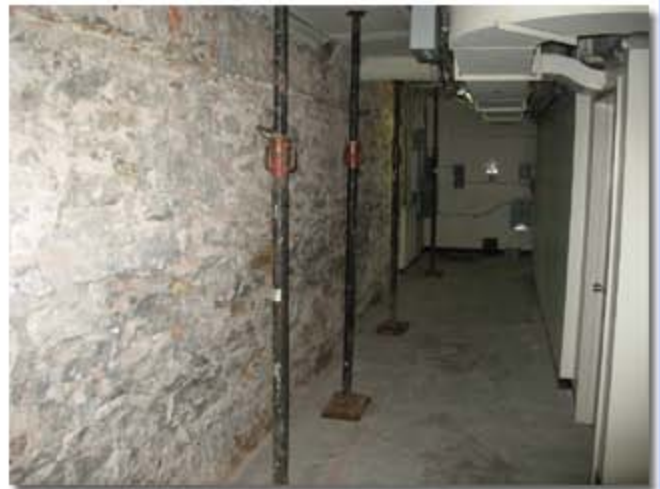
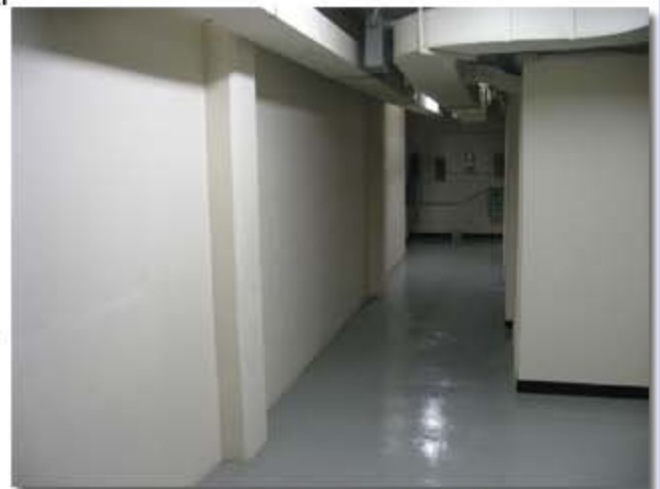
The Bank of Montreal branch located at Barton and James street in Hamilton, ON is situated in a building consisting of an old limestone and mortar foundation wall. Overtime the mortar in the wall degraded and weakened to the point that the wall had begun to collapse.

Advanced Concrete Solutions was contacted to assess the wall condition. Due to the structural integrity of the wall, Advanced Concrete Solutions consulted with a structural engineering firm who designed a repair sequence. ACS was then awarded the contract and constructed a new steel reinforced concrete wall poured adjacent to the existing wall.

- shoring of the existing wall
- removal of all loose and degraded stone and mortar
- epoxy injection of all existing cracks in the wall
- removal of the existing floor and soil excavation to make way for new footings
- installation of underpinning and new footings with rebar reinforcement
- installation of rebar reinforcement for new wall
- form and pour a new one sided concrete wall measuring 13m x 0.3m x 2.7m
- application of an epoxy coating to the existing floor
- apply paint to newly poured wall
