Mount Forest Water Reservoir Crack Injection & Joint Restoration

Project: Mount Forest (Burlington)
Water Reservoir

Location: Burlington, ON

Client: Regional Municipality of
Halton

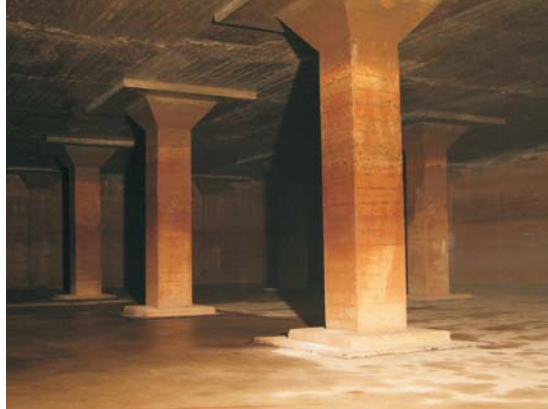
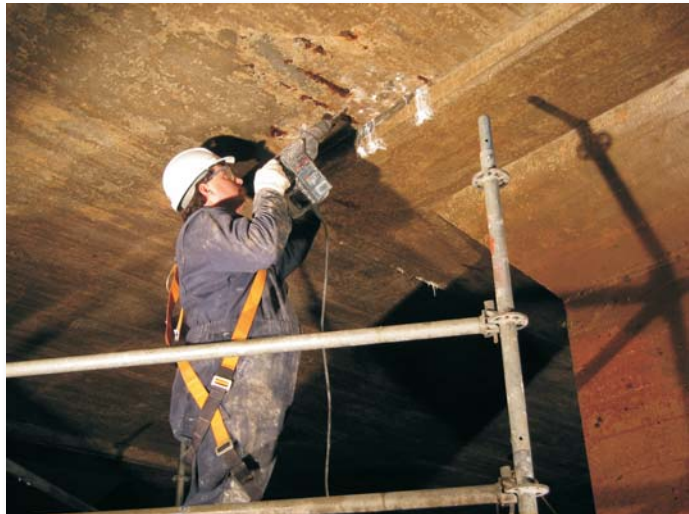
During a scheduled inspection of the underground Mount Forest water reservoir in Burlington, the Regional Municipality of Halton found some cracking in the concrete walls and ceiling. Evidence of possible ground water intrusion was also noticed. In order to avoid potential contamination of the potable water in the two million gallon reservoir, the region decided to have the cracks repaired immediately.

- ensure adherence to all safety and confined space entry requirements
- preparation, cleaning and high-pressure polyurethane injection of 210 lin.ft. of concrete cracks
- removal and replacement of 125 lin.ft. of polyurethane caulking in perimeter floor/wall expansion joints
