## Burlington Water Purification Plant Polyurethane Injection

**Project:** Burlington Water Purification Plant  
Polyurethane Pressure injection

**Client:** Regional Municipality of Halton

**Completion:** January, 2006

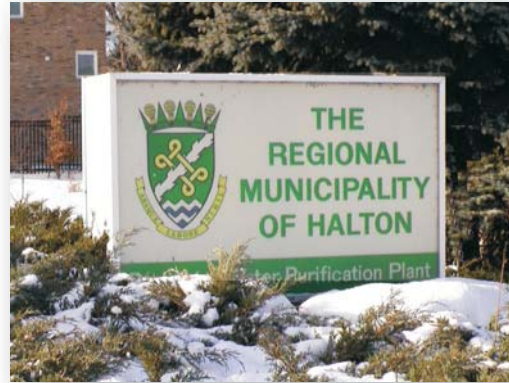
During a recent inspection of the sand filtration cells of the Burlington Water Filtration Plant, the Regional Municipality of Halton found evidence of leakage in an expansion joint between a spillway carrying untreated water and one of the filter cells. In order to prevent potential contamination of the filtered water, the region decided to repair the defective joint.

- ensure adherence to all safety and confined space entry requirements
- preparation, cleaning and repair of the joint using high-pressure polyurethane injection. This procedure utilizes a hydrophobic polyurethane resin which, once cured, produces a flexible, water-tight seal.
