Halton Landfill Site - Methane Collection System Manhole Grouting

Project: Halton Landfill Site - Methane Collection
Chemical grouting of manholes

Client: Region of Halton

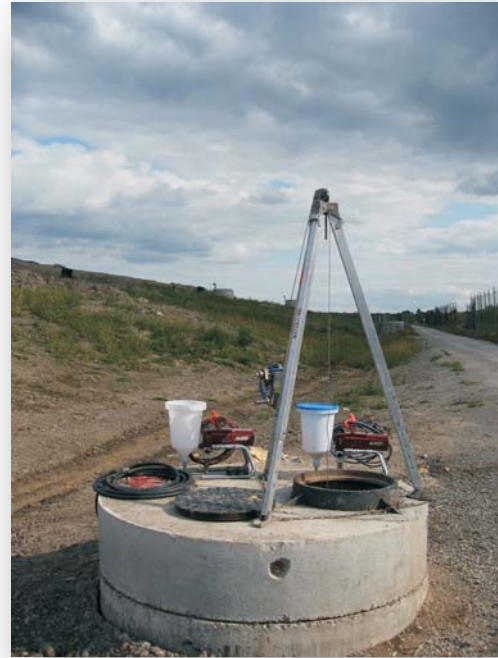
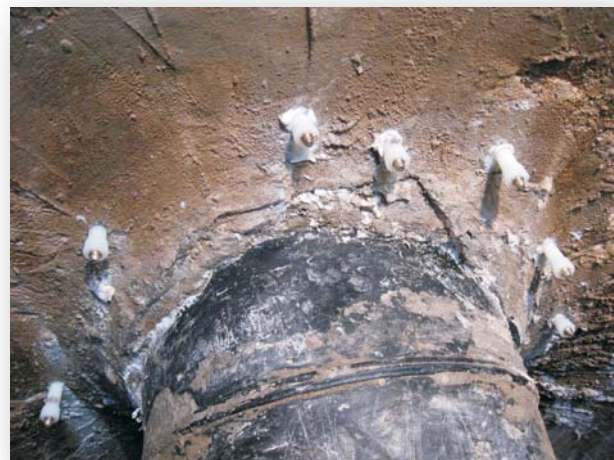
Conestoga Rovers & Associates had recently installed six new manholes as part of the Methane Collection System at the Halton Landfill Site. After installation it was found that the precast concrete manholes were experiencing water infiltration, up to 10 gallons per minute, around pipe penetrations and precast joints. This situation needed to be corrected prior to putting the manholes into service.

Advanced Concrete Solutions was called upon to perform chemical grouting of the manholes. Three different polyurethane resins were utilized to complete the project:

- Elastogel GT1100 for the high water inflow areas.
- Rapid H100 for the void areas around the pipes penetrations.
- PU Flex 100 for the precast manhole joints.

Following confined space entry procedures under OSHA regulations, ACS was able to safely and effectively terminate the water infiltration problems at this facility.
